RESEARCH MEMORANDUM

FLIGHT-TEST MEASUREMENTS OF AILERON

CONTROL SURFACE BEHAVIOUR AT

SUPERCritical MACH NUMBERS

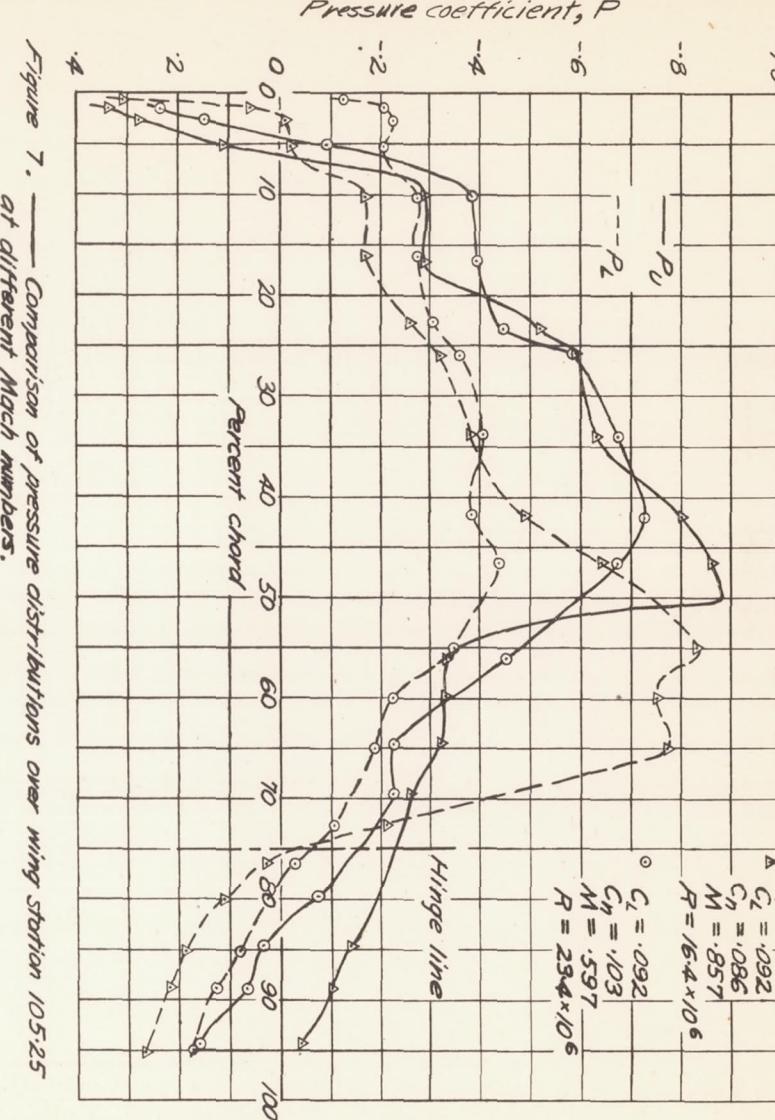
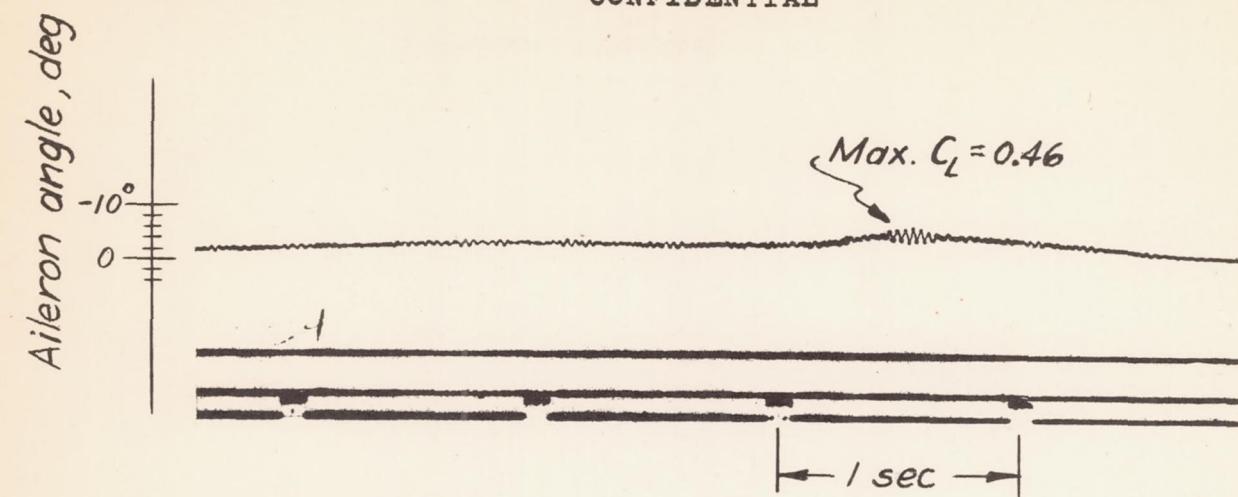
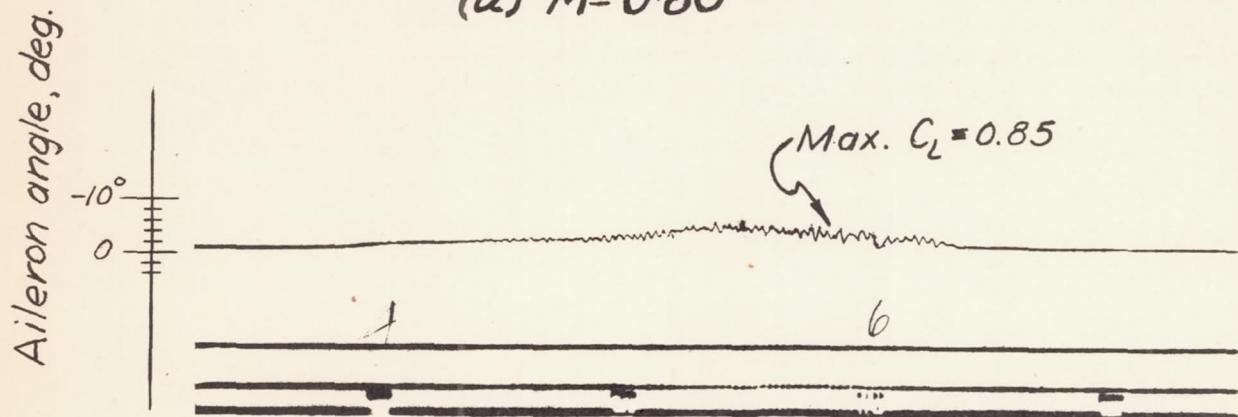
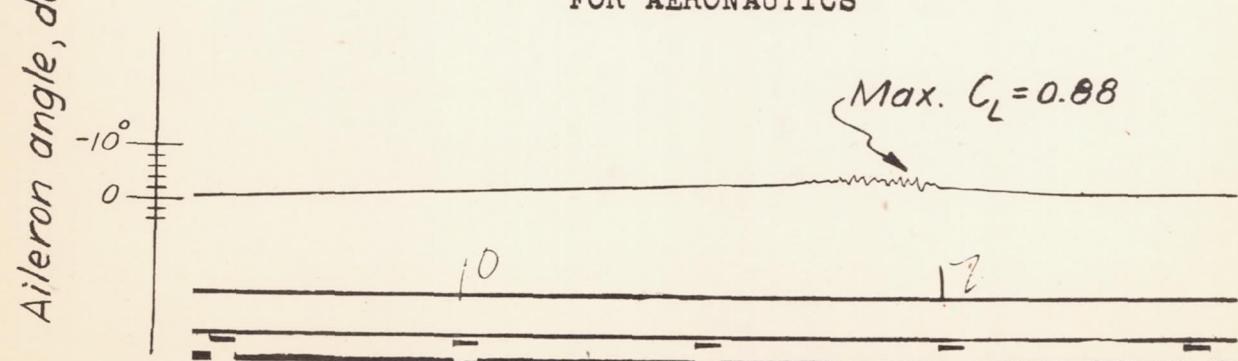
A low-amplitude aileron oscillation known as "buzz" was encountered several times during the flight tests. This buzz was spasmodic when first encountered but as the speed increased became a sustained oscillation with a frequency of approximately 28 cycles per second and a range of movement of about 2° . Typical aileron-angle records during buzz at various Mach numbers are reproduced in figure 9. Figure 10(a) is a photograph of the left aileron taken during the buzz, showing the blurred image of the trailing edge. The angle between the converging images of the upper edge of the black stripe across the aileron indicates the small amplitude of the motion.

Figure 9.- Typical records of right aileron position during pull-ups at various Mach numbers showing oscillations.

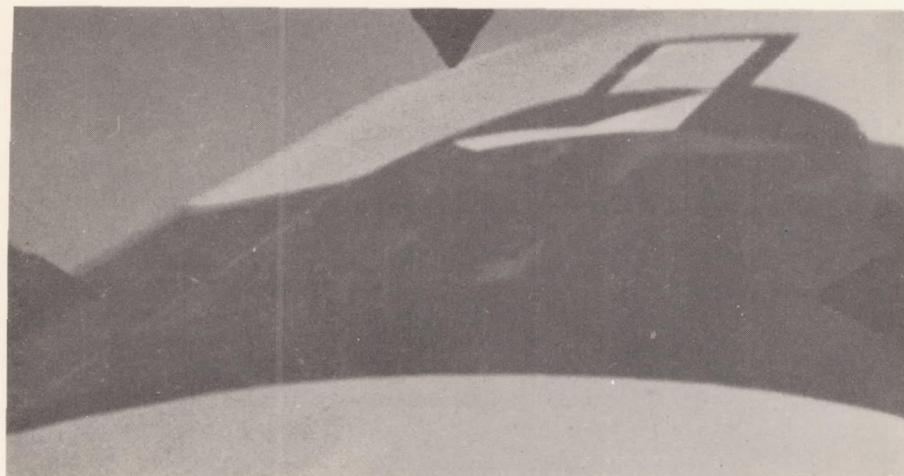
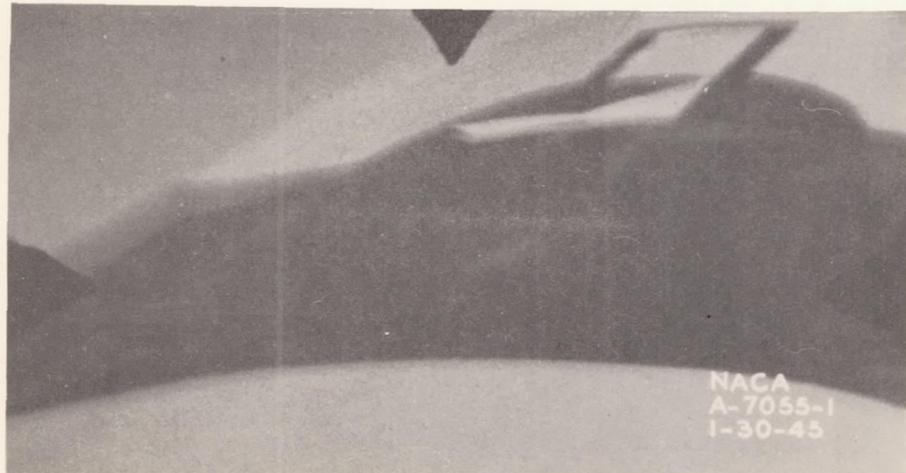
(a) During buzz, $M = 0.826$, $C_L = 0.01$.(b) During flutter, $M = 0.865$, $C_L = 0.35$

Figure 10.- Photographs of the left aileron during aileron oscillations.

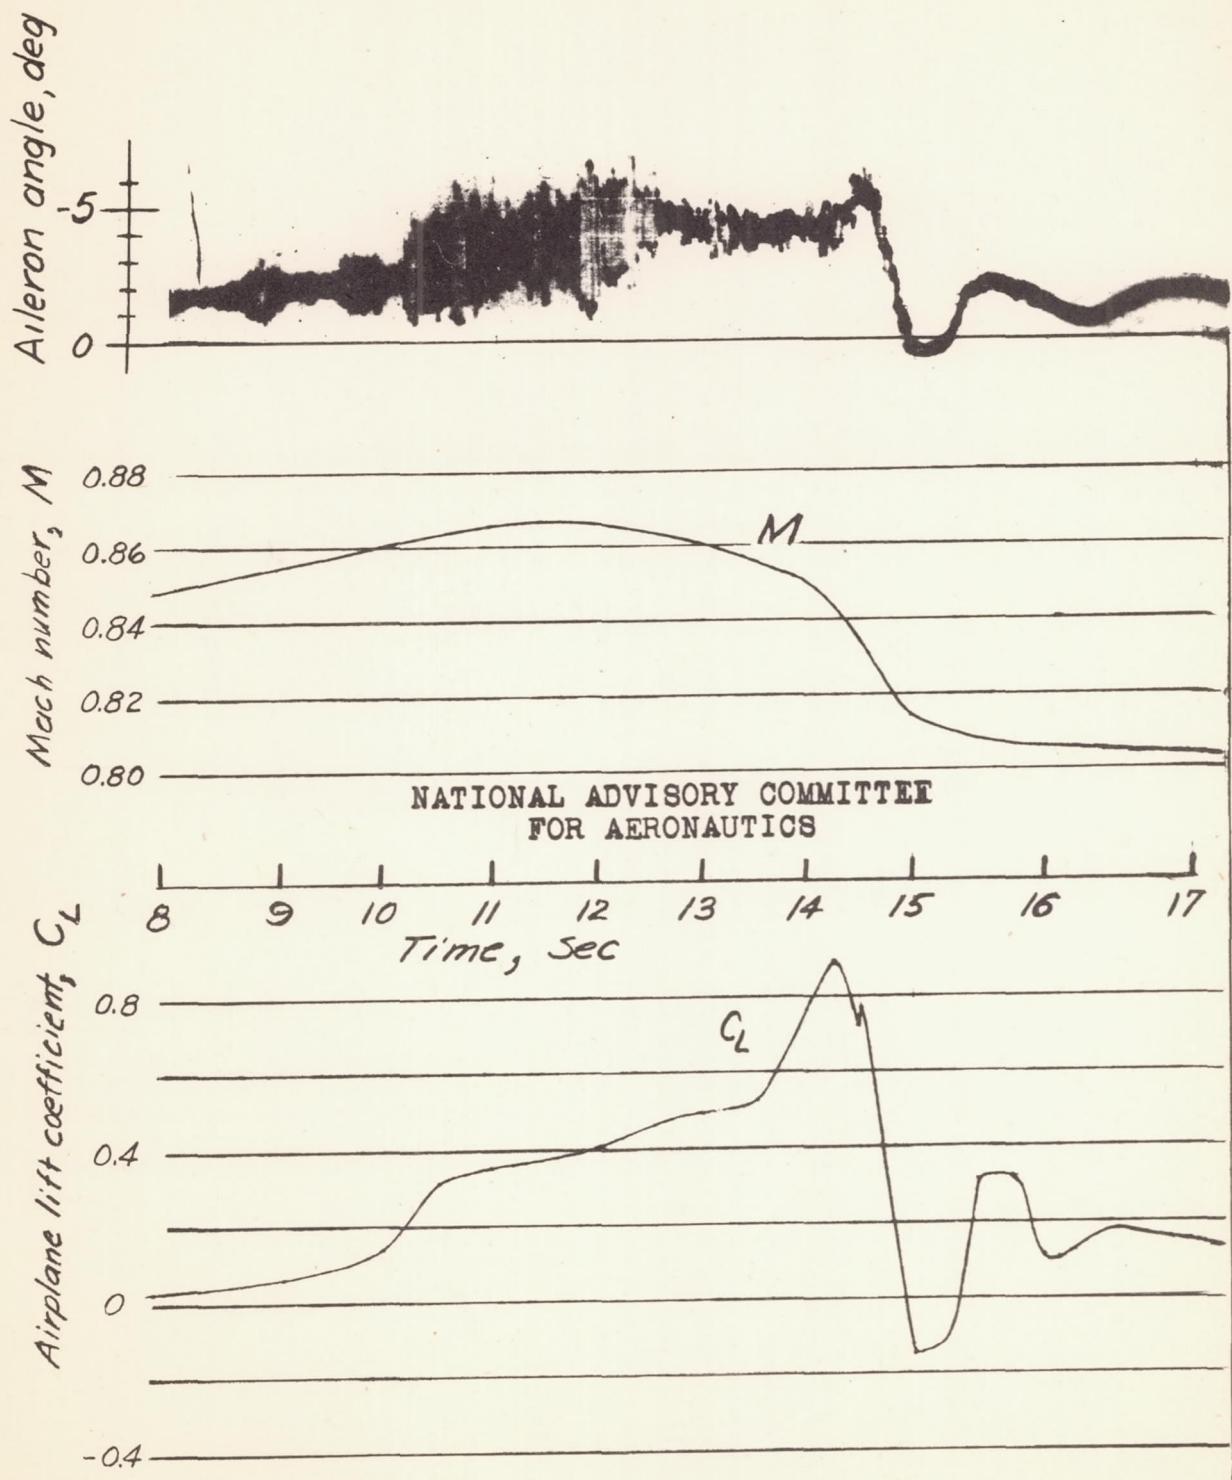
At a Mach number of about 0.85 during a high-speed dive the buzz developed into a much higher amplitude oscillation of sufficient violence to cause the trailing edge of the left aileron to buckle. Figure 11 is a time history of a portion of this dive and pull-out showing the record of the right aileron position. The records indicated that the aileron oscillated about an up-position over a range of about 6° , but the frequency could not be determined. The photograph of the left aileron during the flutter (fig. 10(b)) shows the considerable increase in the angle formed by the images of the edge of the black stripe. The double image of the star insignia indicates the amount of general buffeting accompanying the aileron oscillations.

Figure 11.— Records of right aileron upfloat and oscillations during dive recovery at Mach number and airplane lift coefficient shown.

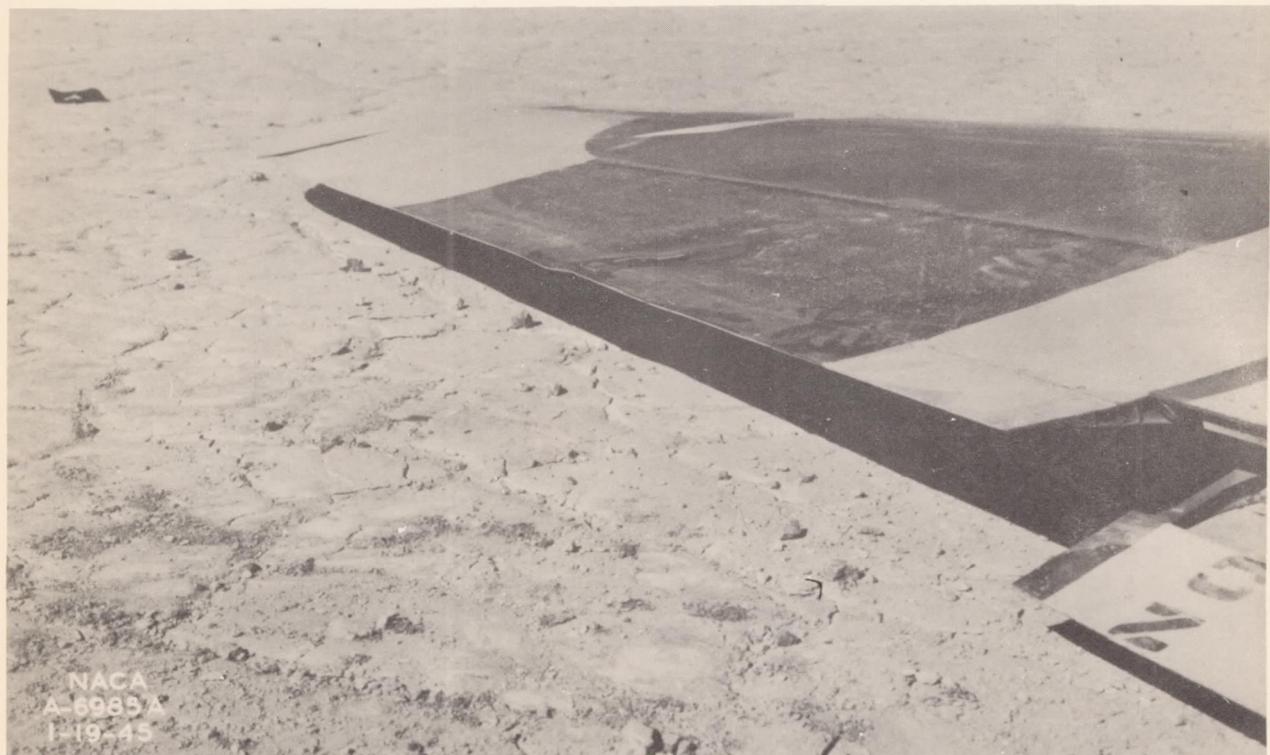
Fig. 12

Figure 12 is a photograph of the aileron taken after the flight to show the buckle in the trailing edge caused by the flutter.

Figure 12.- Photograph of left aileron taken on ground after dive recovery showing buckled trailing edge caused by severe flutter.

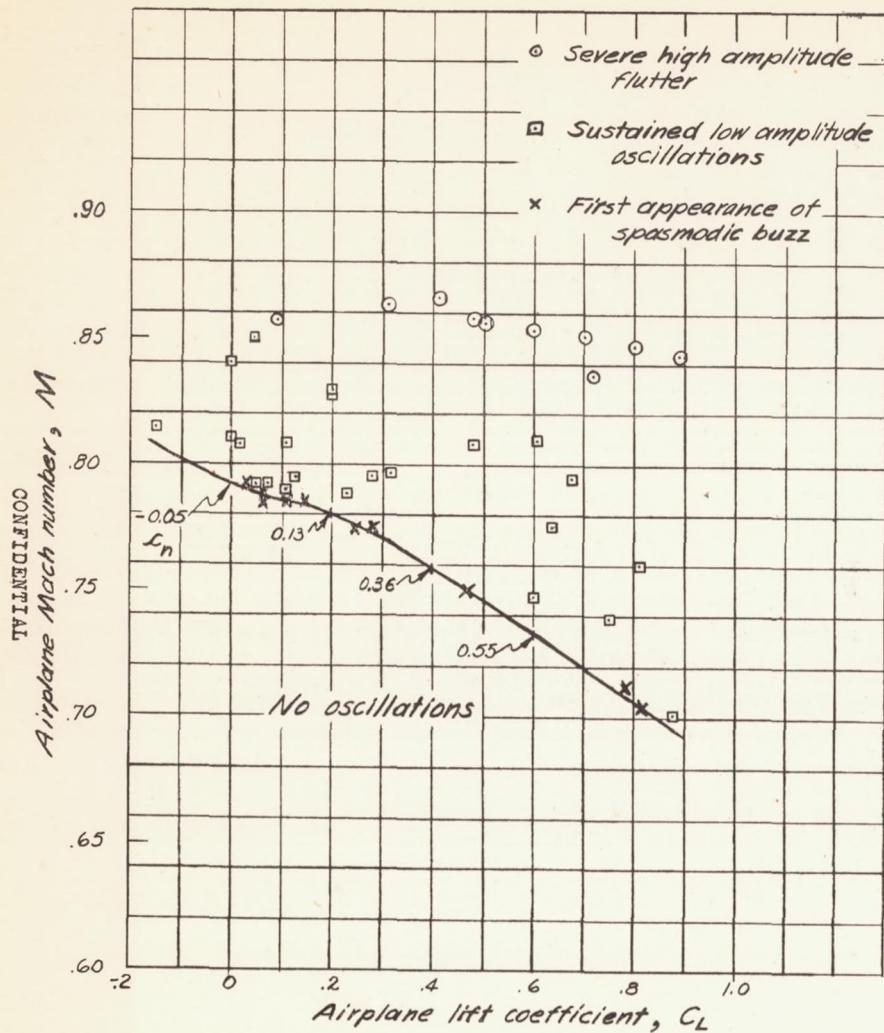
A flight-test boundary defining the first appearance of spasmodic buzz in terms of Mach number and airplane lift coefficient is presented as the solid line in figure 13. Corresponding values of the average section normal-force coefficient of the wing section through the aileron are spotted on the curve for convenient reference.

At higher Mach numbers the buzz became a steady and sustained motion, as indicated on figure 13 by the square symbols. Further increases in Mach number resulted in transition to the more violent and severe flutter indicated by the circles. It is probable, however, that the location of this transition can be shifted by changes in the amount of cable tension or aileron restraint. For this reason the specific increment in Mach number indicated in figure 13 between the buzz and the more dangerous oscillation should not be interpreted as a generally applicable factor of safety.

Figure 13. — The range of Mach number and airplane lift coefficient in which aileron oscillations occurred on the test airplane.

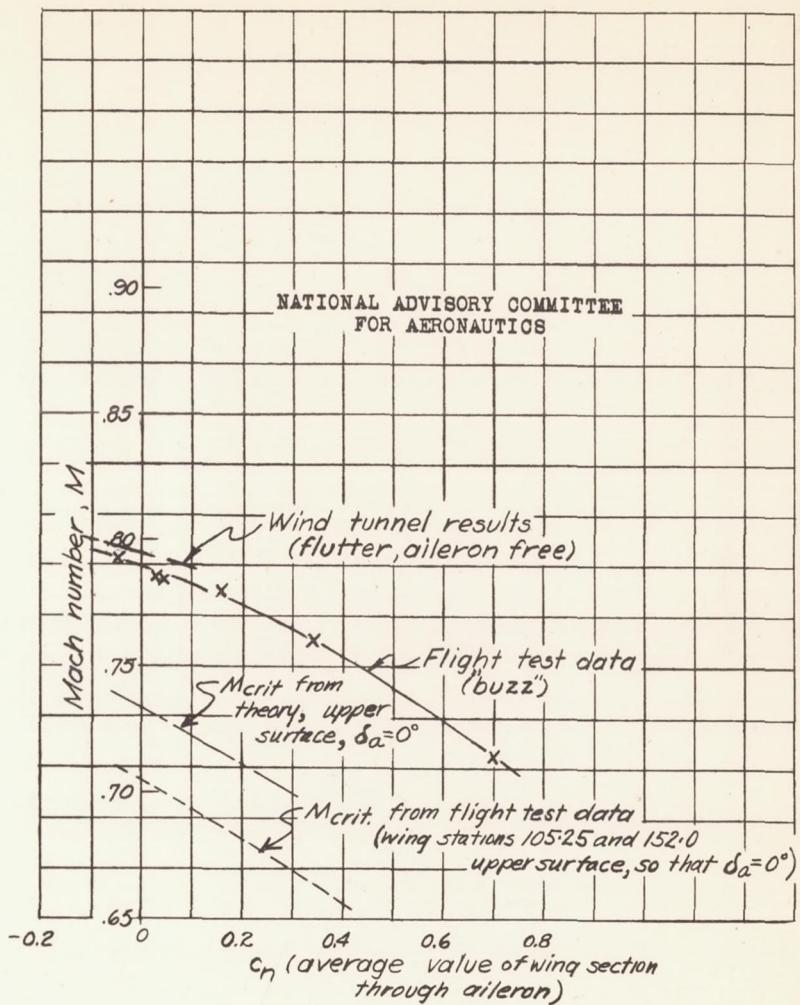
Figure 14 is a boundary for the first appearance of aileron oscillations which is expressed in terms of the average section normal-force coefficient of the wing section through the aileron rather than the airplane lift coefficient. The flight-test boundary falls only 0.007 Mach number below the data¹ from tests in the Ames 16-foot high-speed wind tunnel of a partial-span installation of an identical full-scale wing with a free aileron. This close agreement between tests conducted with high cable tension and with no restraint at all demonstrates the validity of using the buzz boundary as a signal of possible dangerous flutter at some higher Mach number, depending upon the amount of restraint and damping in the aileron control system.

The section critical Mach numbers, determined both from flight tests and from theory, are also presented in figure 14 to show that the buzz actually occurs at a practically constant increment of Mach number above the section critical Mach number, regardless of the value of the section normal-force coefficient or the airplane lift coefficient.

Figure 14.— Variation of Mach number at which aileron oscillations occur with normal-force coefficient.
